New York State Department of Transportation

Yellow Flag NB22CTW004

BIN: 1065318

Location: Span 125 Girder G9 at Pier 124

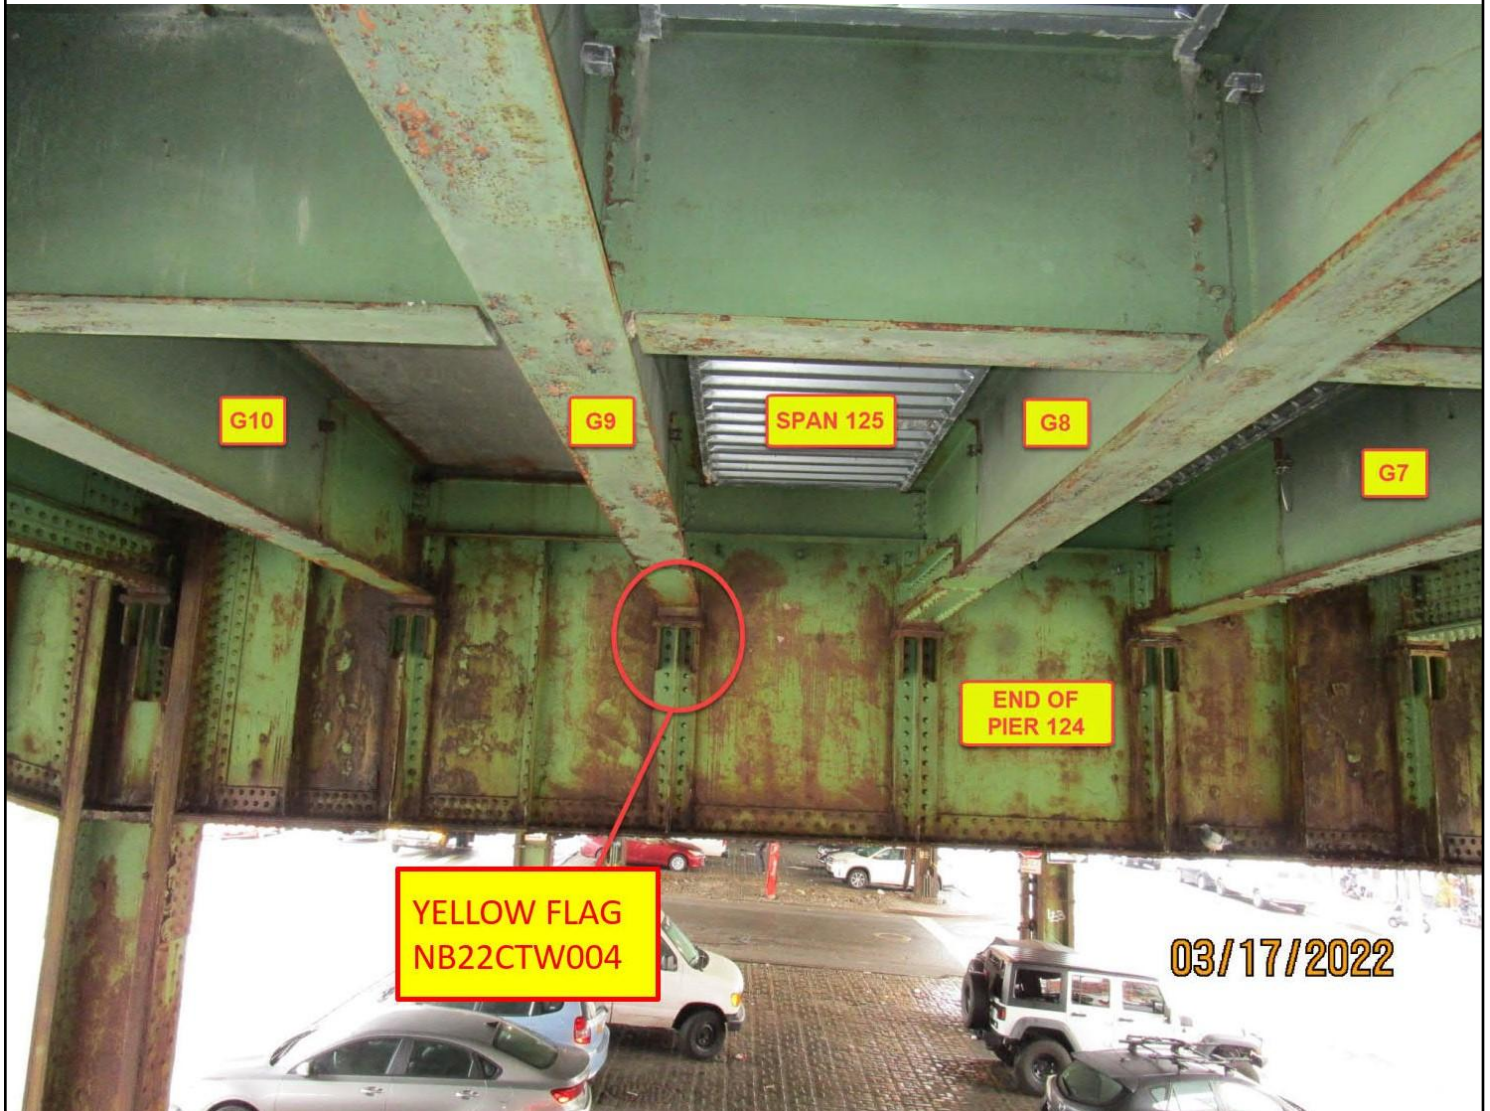
Photo Number: 1

Attachment Description: General view of Girders G7 thru G10 in Span 125 at Pier 124. Looking Begin.

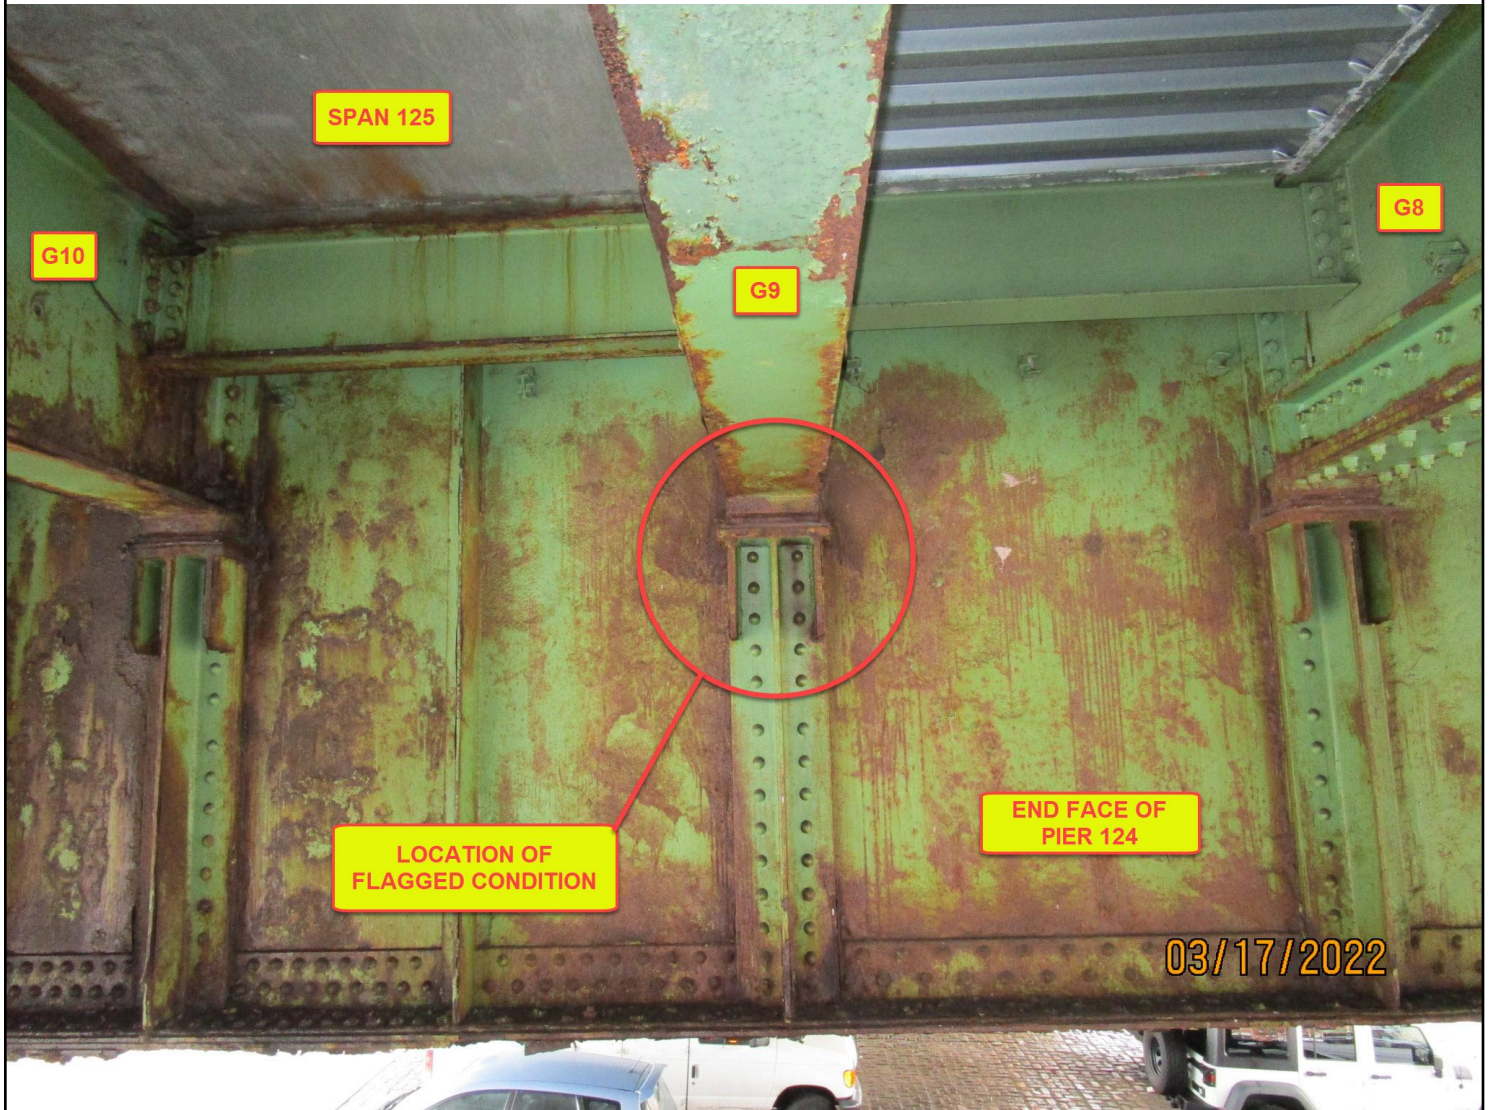
Photo Number: 2

Description: The end of Girder G9 in Span 125 at Pier 124 exhibits severe corrosion resulting in an overall web bearing area section loss of approximately 39% (previously 40%) and an overall shear web area section loss of approximately 15% (previously 14%) with an average overall localized section loss of approximately 55% (previously 56%) for 5"L x 4"H area directly above the bearing below the guide angle (Photos 3 and 4). Also, the lower web of the girder adjacent to the web bearing area exhibits 20% average section loss for 3'L x 3"H above the bottom flange. There is no significant change since the last inspection. (Refer to sketch for more details)

Attachment Description: General view of the flagged condition at Girder G9 in Span 125 at Pier 124. Looking Begin.

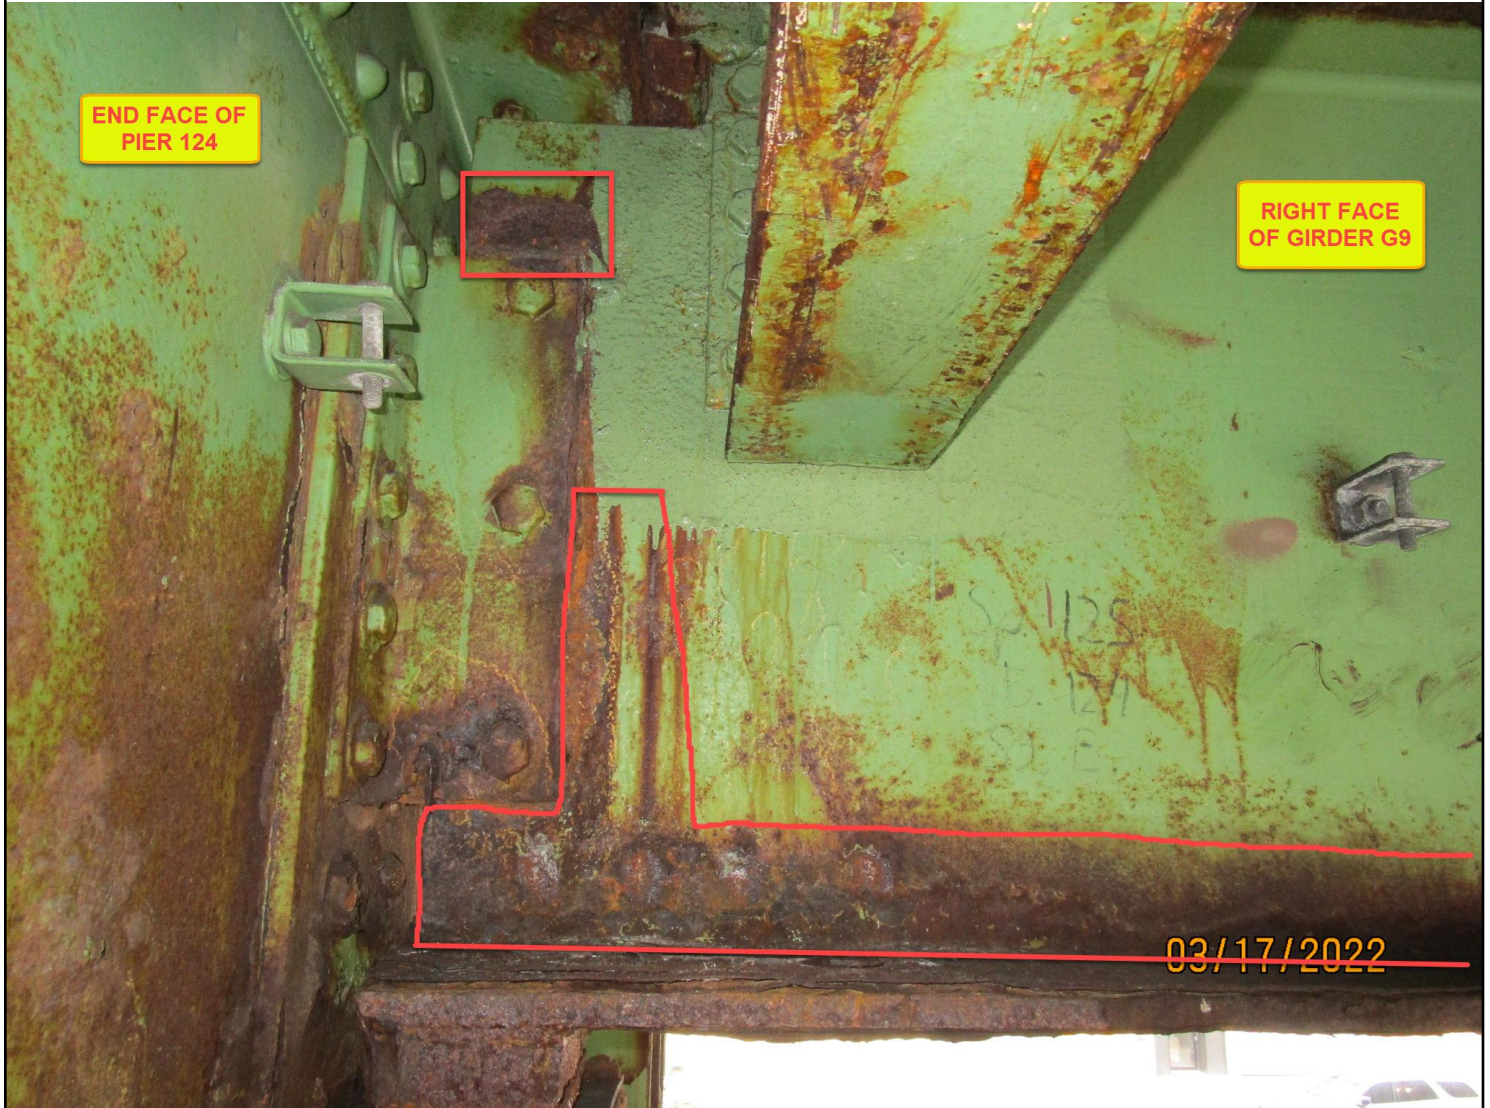
Photo Number: 3

Attachment Description: The right face of Girder G9 in Span 125 at Pier 124. The end of the girder exhibits severe section loss at the lower web above the bottom flange and web height adjacent to the guide angle. Looking Left.

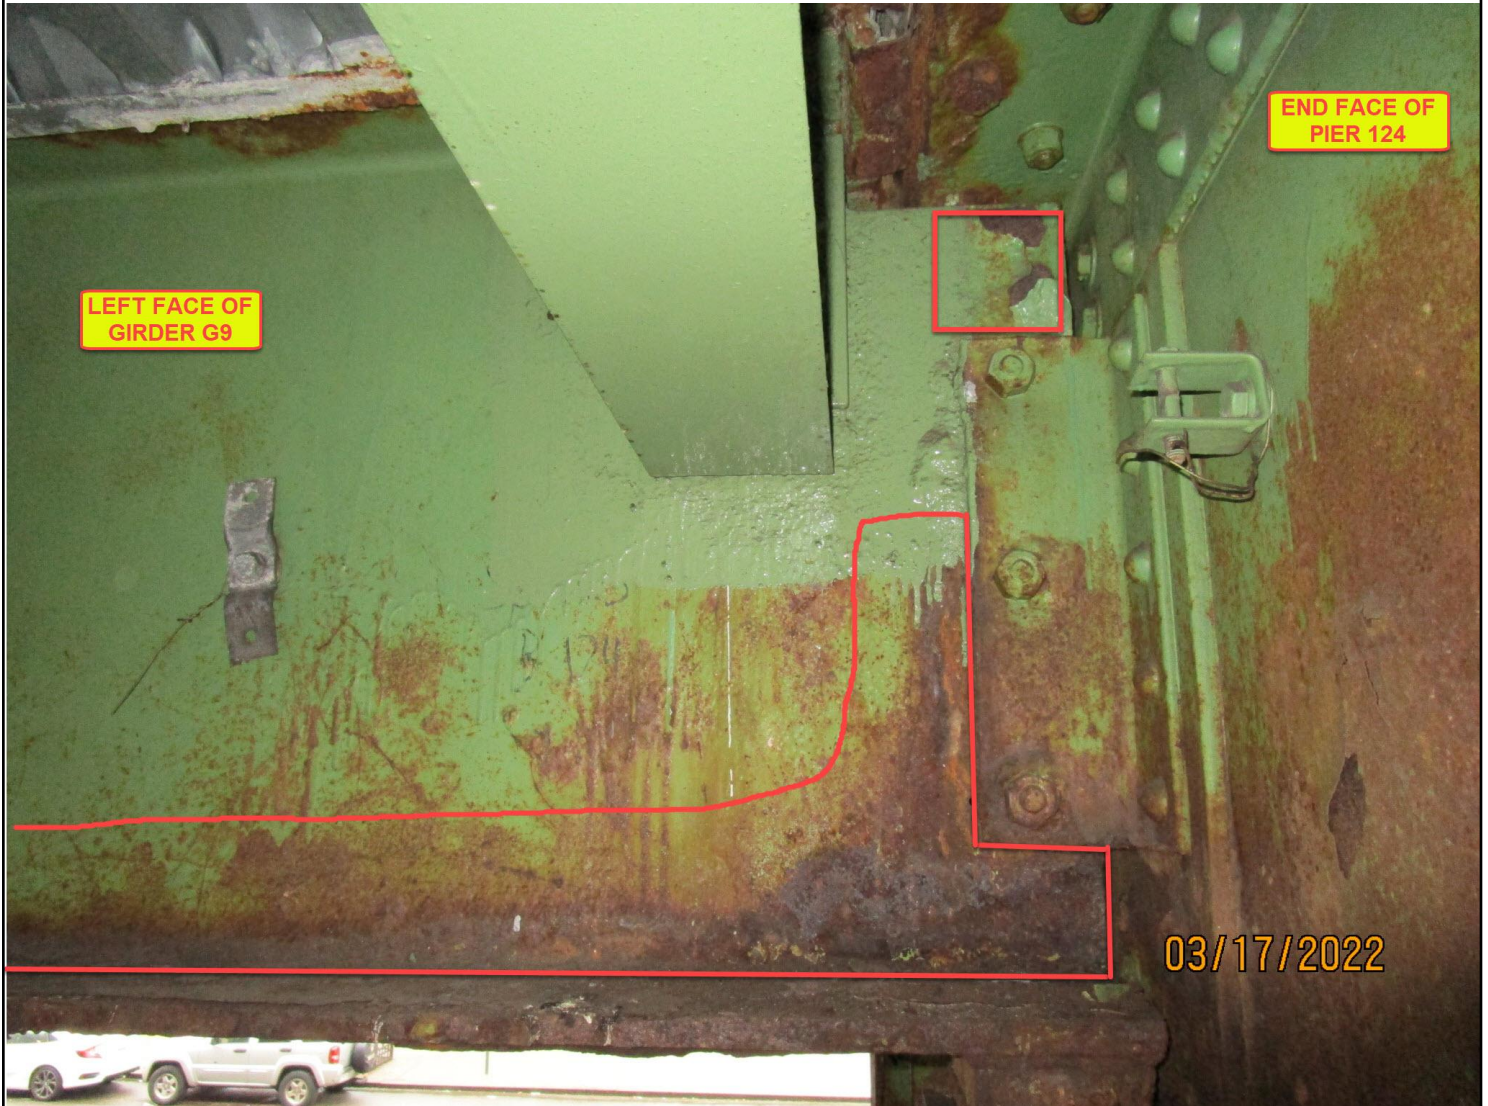
Photo Number: 4

Attachment Description: The left face of Girder G9 in Span 125 at Pier 124. The end of the girder exhibits severe section loss at the lower web above the bottom flange and web height adjacent to the guide angle. Looking Right.

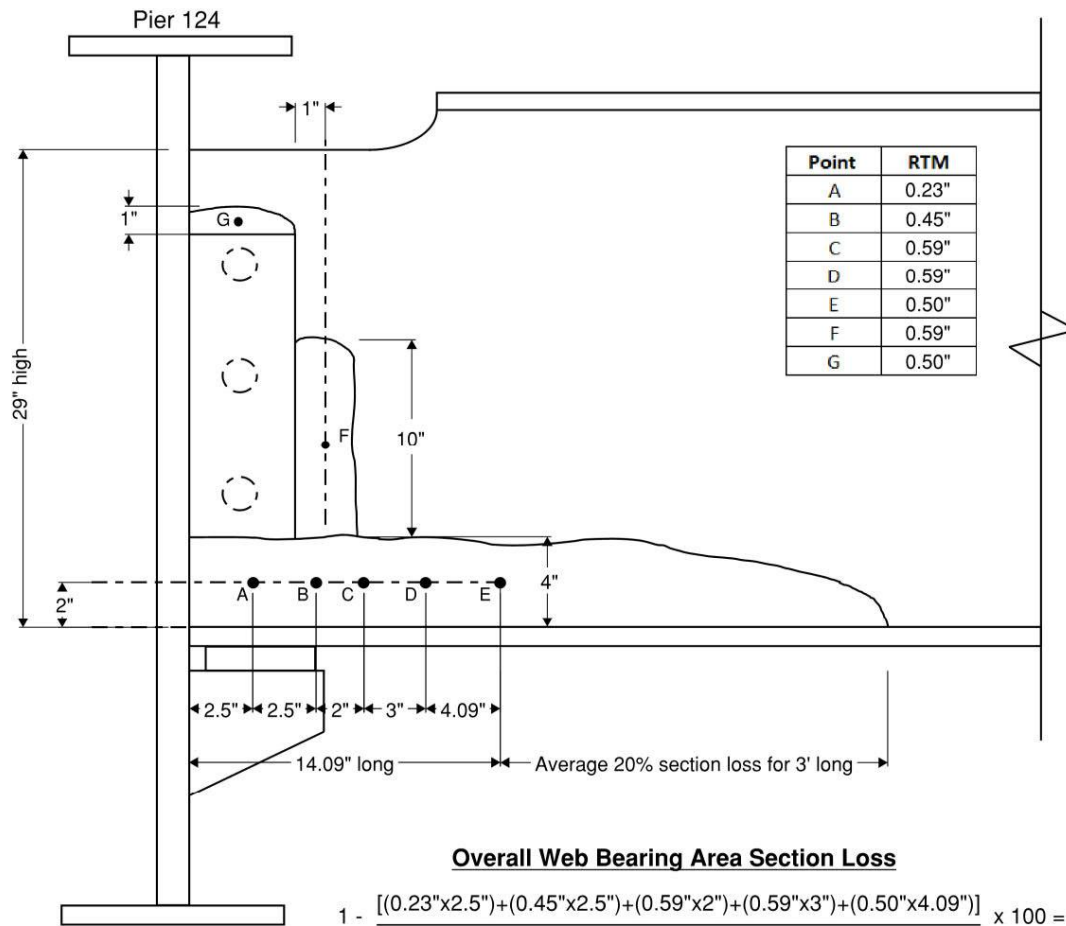
Right Face of Girder G9 Sketch in Span 125 at Pier 124

Overall Web Bearing Area Section Loss

$$1 - \frac{[(0.23 \times 2.5) + (0.45 \times 2.5) + (0.59 \times 2) + (0.59 \times 3) + (0.50 \times 4.09)]}{11.03 \text{ in}^2} \times 100 = 39\%$$

Overall Shear Web Area Section Loss

$$1 - \frac{[(0.45" \times 4") + (0.59" \times 10") + (0.50" \times 1") + (0.783" \times 14")]}{22.71 \text{ in}^2} \times 100 = 15\%$$

- As-built web thickness = $0.783"$
- Length of bearing area = $18 \times \text{web thickness} = 18 \times 0.783" = 14.09"$
- Overall bearing area = $14.09" \times 0.783" = 11.03 \text{ in}^2$
- As-built shearing web area = $29" \times 0.783" = 22.71 \text{ in}^2$
- Adjacent Girder G8 has previously installed reinforcement steel plates and angles at the end of girder
- Adjacent Girder G10 exhibits up to 35% section loss at the lower web above the bottom flange and up to 25% section loss for the full height of the web adjacent to the guide angles.

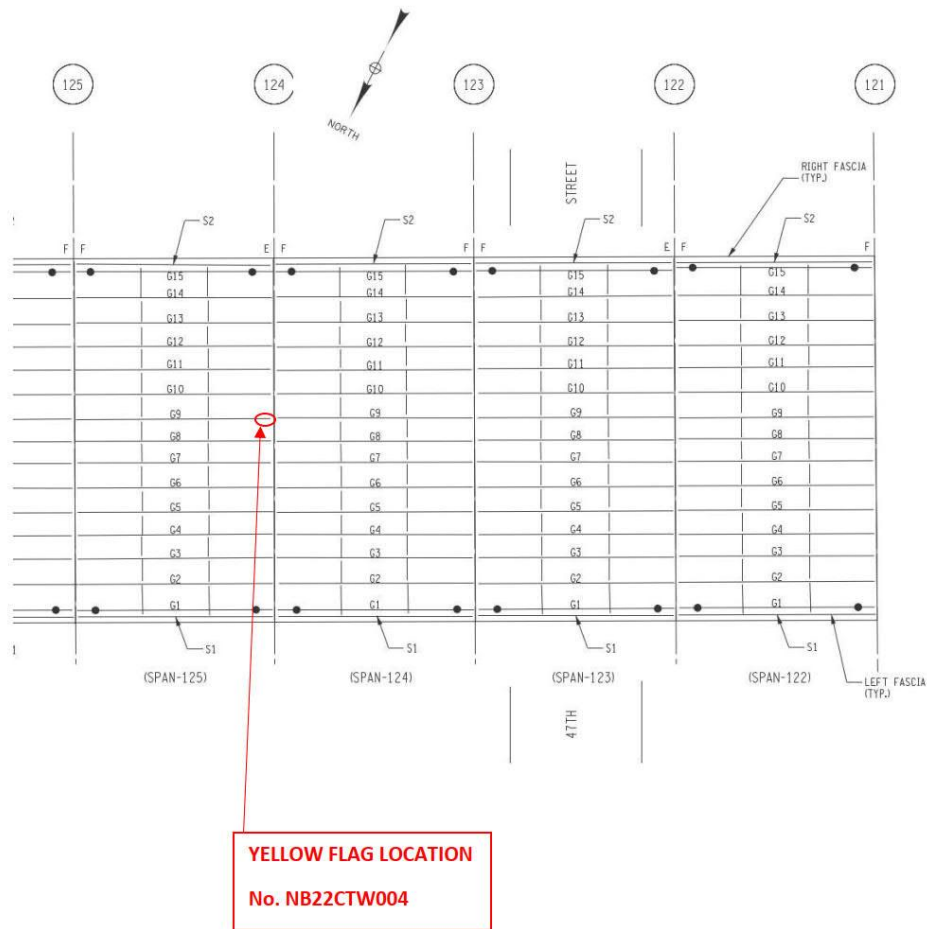
Photo Number: 6

Attachment Description: Span 125 G9 at Pier 124 Framing Plan
